PROTECTIVE TREATMENTS FOR WESTERN REDCEDAR SHINGLE AND SHAKE ROOFS

REPORT

Washington State Parks & Recreation Commission

April 15, 2018

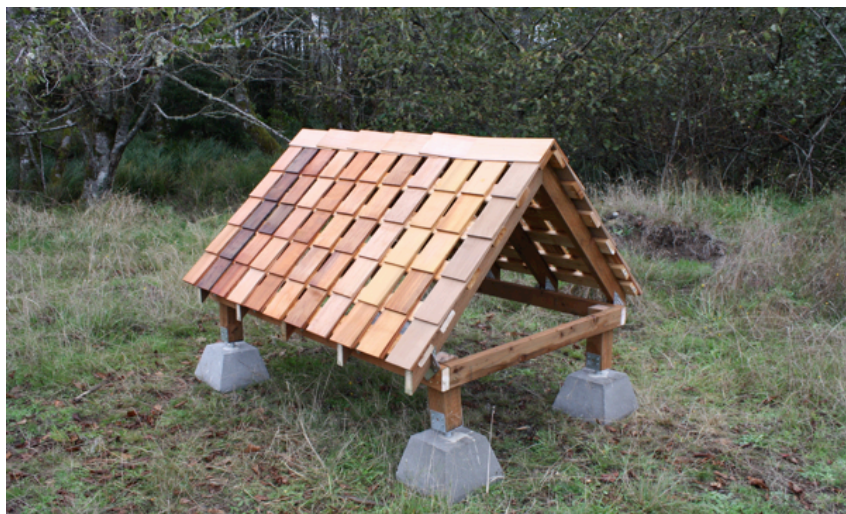
Figure 4. Experimental set up at Cape Disappointment State Park. Oceanic exposure.

The same layout of treated shingles was repeated on each slope, containing eleven treatment groups in vertical rows with a 1" gap between the groups. Each treatment group, as well as an untreated control group comprised five replicate samples on each exposure. Shingles were nailed with standard stainless steel ringshank roofing nails overlapping at half their length. The base structure was constructed of pressure treated 2 x 4 lumber, with 4 x 4 posts on pier blocks with galvanized brackets. The shingle nailers were utility grade cedar to prevent contact between tested products and wood preservative components in pressure treated lumber of the frame. Untreated shingles were used both as a “starter” course and for a ridge cap, simulating a typical assembly of this roofing type. Simpson ties were used for rafter connections.

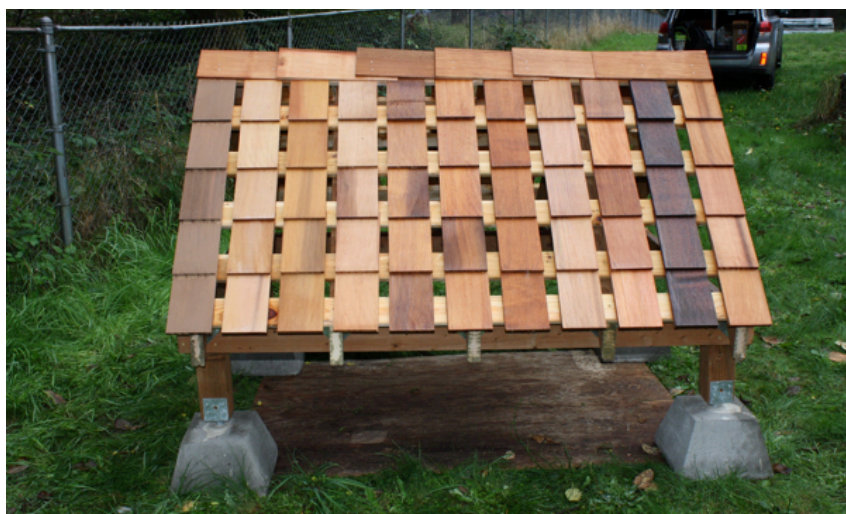
Figure 5. Experimental set up at Beacon Rock State Park. Maritime exposure.

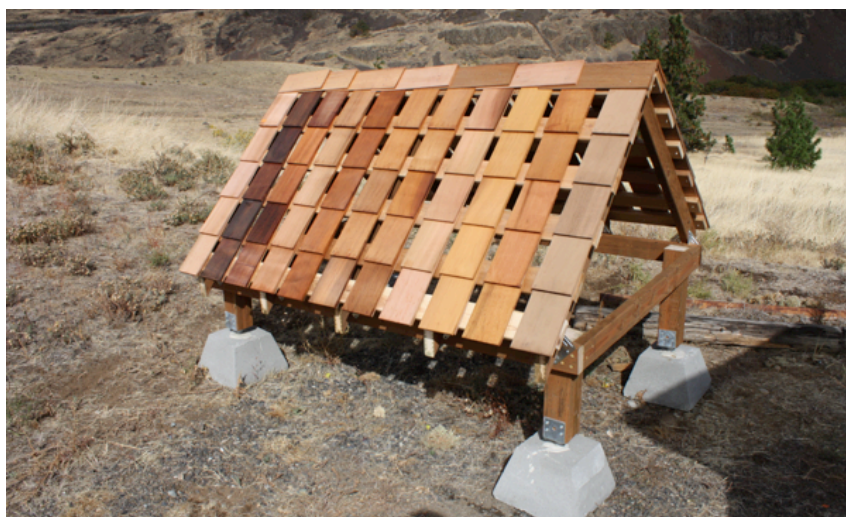
Figure 6. Experimental set up at Columbia Hills State Park. Arid exposure.

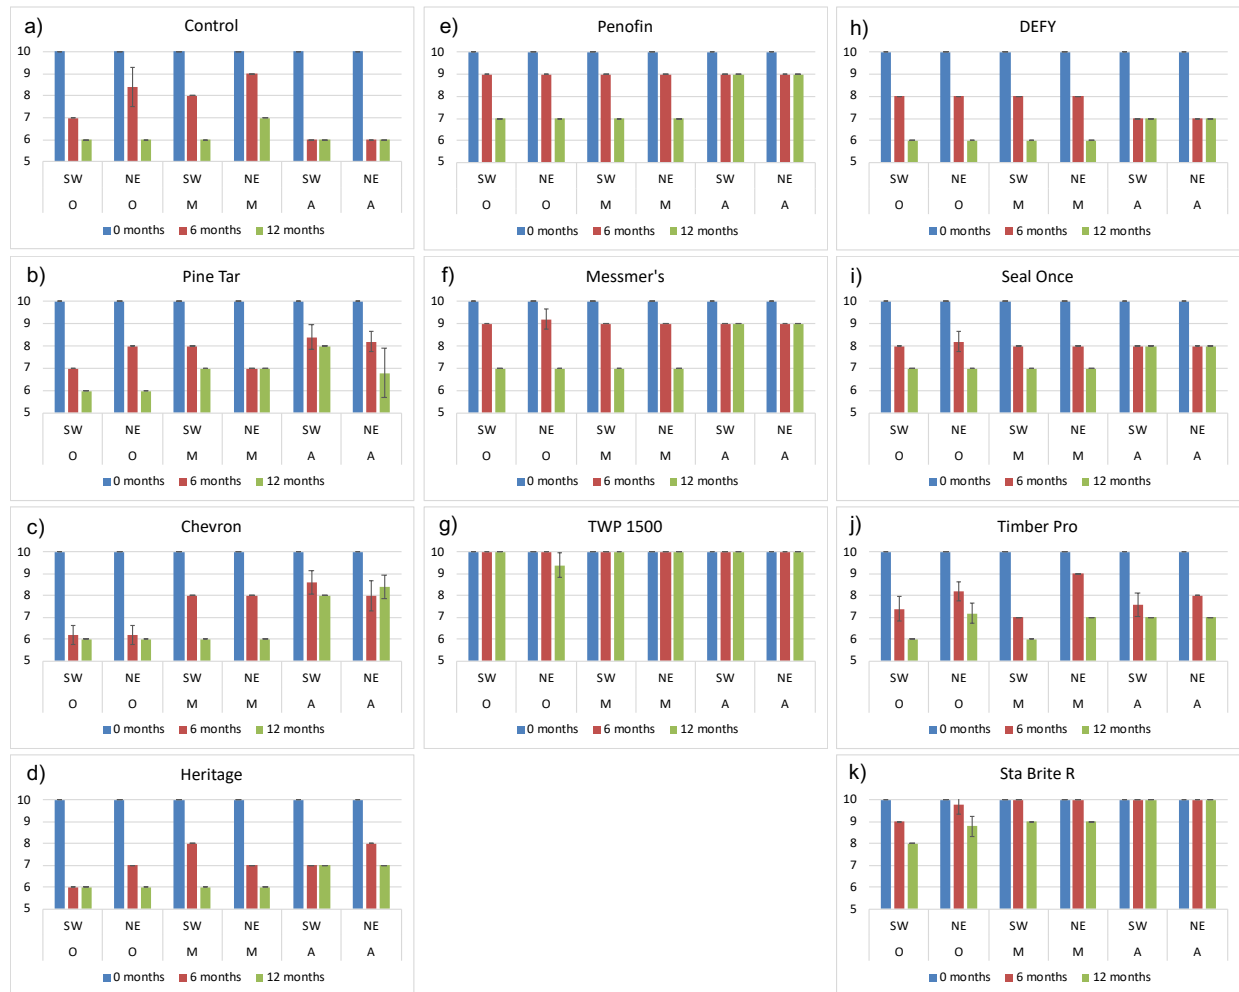
Figure 7. Average ratings and standard deviation (SD) for color change for individual test groups for Oceanic (O), Maritime (M), and Arid (A) exposures for SW and NE elevations.

Color change was one of the most significant outcomes of natural weathering exposure at all investigated sites and for all treatments, with the exception of TWP 1500 which sustained no color change at any sites and for Sta Brite R, which did not have color change at the Arid site (Figure 7). All other coated and uncoated control groups had significant loss of color at the end of the 1st phase, with further changes taking place for most groups over the 2nd phase of natural weathering exposure.

Most rapid color loss was observed in untreated control groups (Figure 8.). They completely lost the natural color of western redcedar after six months of weathering (1st phase) at Arid exposure, followed by Maritime and Oceanic exposures where the color ratings were higher at the end of the 1st phase, but further decreased over the 2nd phase to near complete loss (Figure 7a).

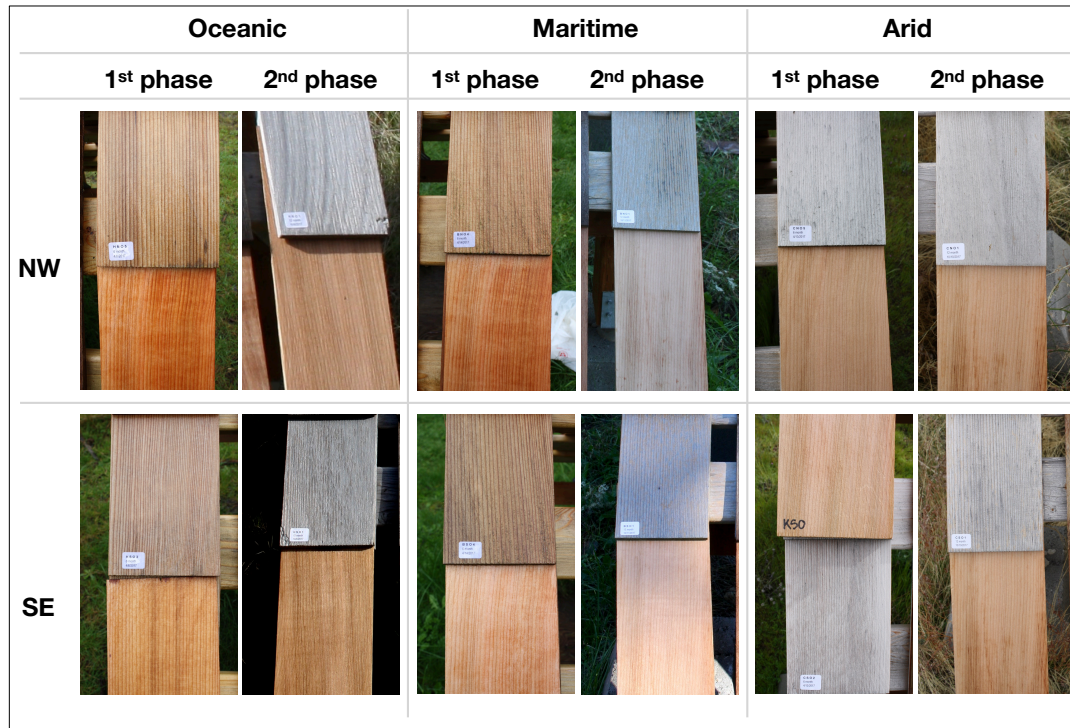
Figure 8. Comparisons for color and graying between uncoated control shingles (white label) and unweathered control following 1st and 2nd outdoor exposure phases for NW and SE exposures at three testing sites.

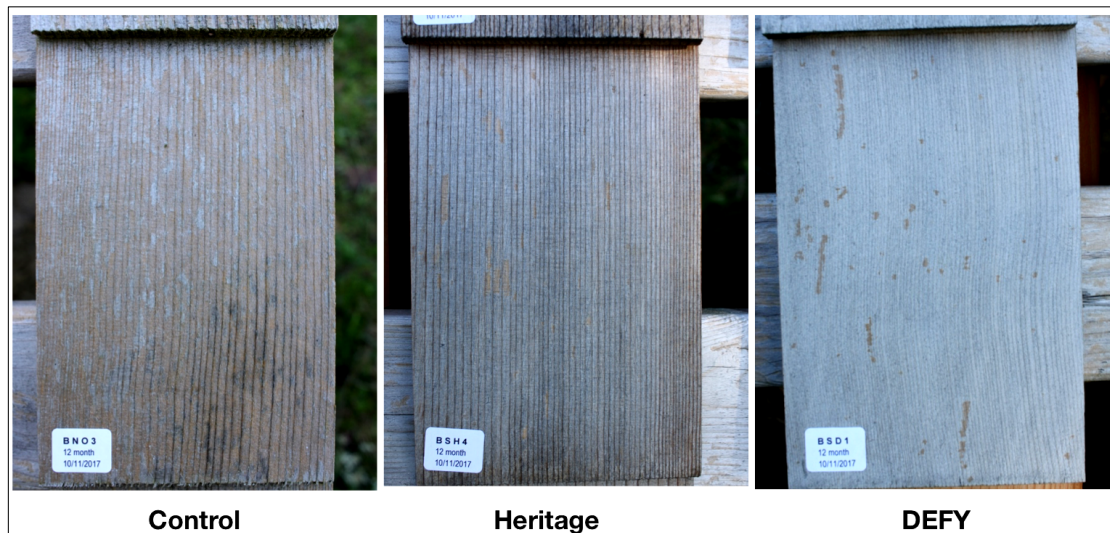
Figure 11. Surface erosion on uncoated control and Heritage and DEFY coated shingle. Maritime site after 12-month outdoor exposure.

Surface erosion on uncoated control shingles resulted from weathering of wood caused by the combined action of UV radiation, precipitation, and wind (Schniewind, 1963). In contrast, erosion observed on samples coated with oil-borne coatings resulted from the failure of coatings caused by similar environmental factors to those responsible for weathering of wood that was, in some instances, followed by the weathering of unprotected wood. The erosion pattern was somewhat different on surfaces coated with water-borne coatings appearing to be caused by mechanical action.

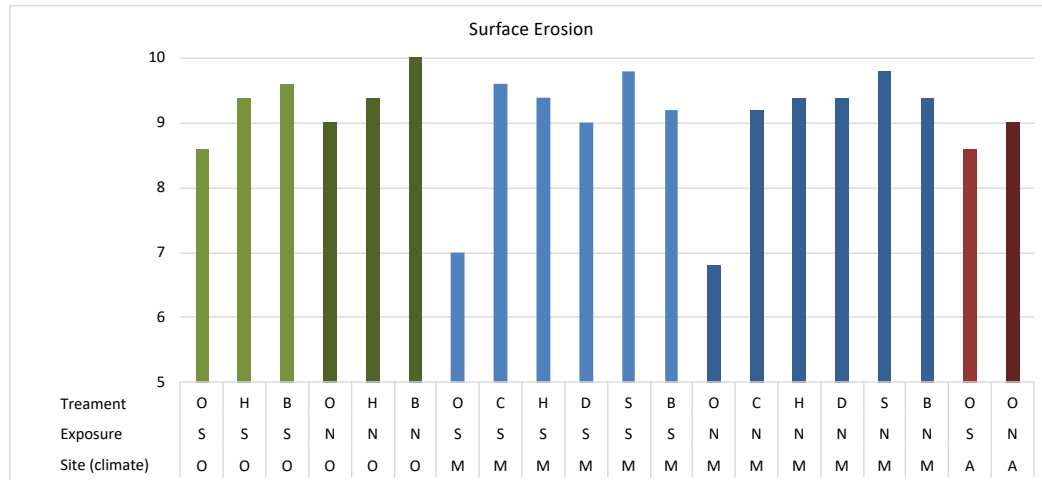
Figure 12. Mean ratings and standard deviation (SD) for surface erosion for control (O), Chevron (C), Heritage (H), DEFY (D), Seal Once (S), and Sta Brite R (B) (first row of category labels on X axis) following 12-month outdoor weathering for southwest (S) and northeast (N) exposure (second row of category labels on X axis) at Oceanic (O), Maritime (M) and Arid (A) sites (third row of category labels on X axis).

On all test sites and elevations, the highest amount of erosion was observed on uncoated control shingles. Among the test sites, the most severe effects in terms of the amount of erosion and the number of coatings that sustained damage was observed at the Maritime site with six affected test series, followed by the Oceanic site with three affected test series, and the Arid site with only the uncoated control group showing erosion. No consistent trends in the extent of surface erosion were apparent between SW and NE elevations at any sites.

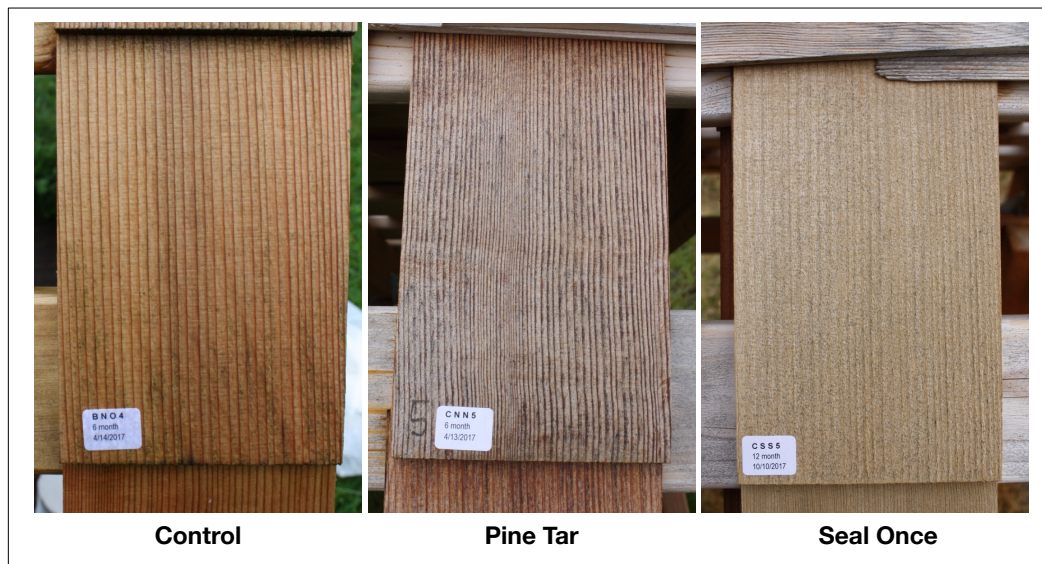
Figure 13. Appearance of green growth on the surface of uncoated control shingles and of black mold on shingles coated with Pine Tar and Seal Once.

Surface growth was observed on some, but not all, treatments following the 1st and 2nd phase of outdoor exposure. Two general types of surface growth were distinguished. The first type appears to be black mold and was the most frequently observed form of surface growth. The second type was the green growth that is usually associated with algae and mildew and was only observed on uncoated control samples at the Maritime site (Figure 13).

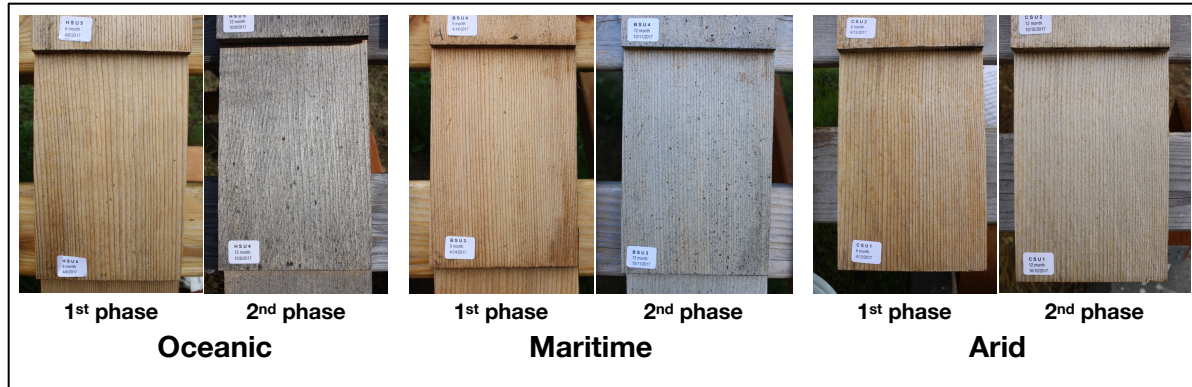
Figure 15. Surface growth on shingles coated with Timber Pro after 1st and 2nd testing phase respectively for three exposures.

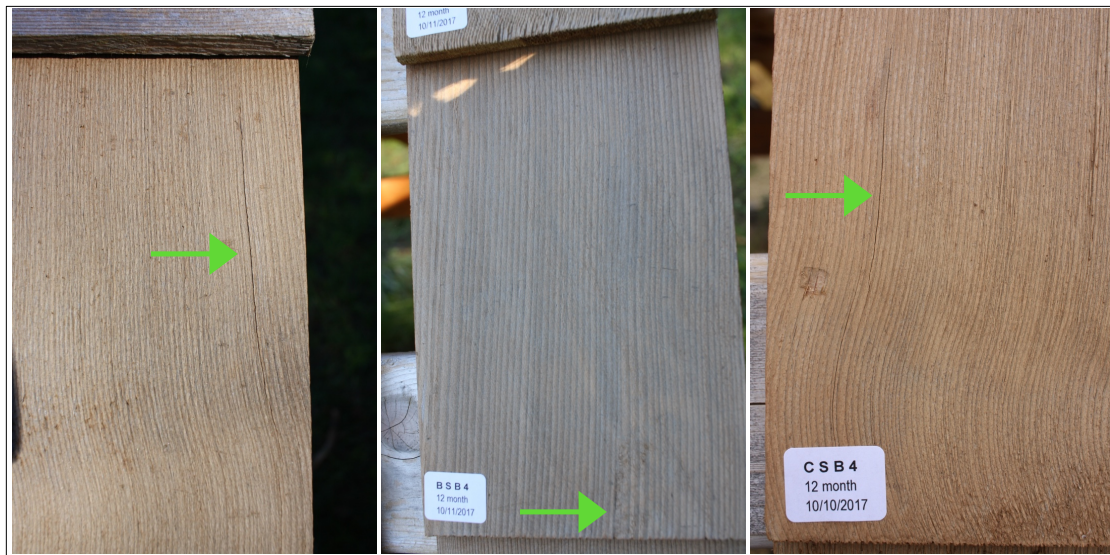
Figure 16. Examples of surface checking following 12-month outdoor exposure.

First occurrences of surface checking on tested shingles were observed after 12 months of outdoor exposure. Most checks appeared as hairline checks (Figure 16) of different lengths along the grain. The largest number of test groups that developed checks was observed at the Oceanic site (DEFY, Seal Once, Sta Brite R, Pine Tar, and Chevron), followed by the Maritime site, where checking was observed on test groups coated with DEFY and Sta Brite R, and the Arid site, where checking was observed on Timber Pro and Sta Brite R coated test groups (Figure 17). Many of the test groups had checking develop only on one out of five samples.

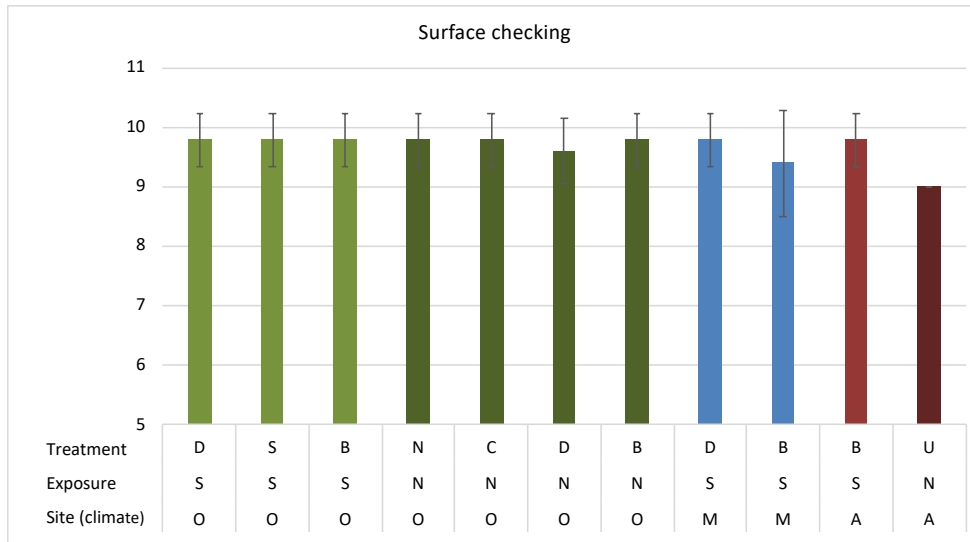
Figure 17. Mean ratings and standard deviation for surface checking following 12-month outdoor exposure at Oceanic (O), Maritime (M) and Arid (A) site, for southwest (S) and northeast (N) exposure for DEFY (D), Seal Once (S), Sta Brite R (B) Pine Tar (N), Chevron (C), and Timber Pro (U).

While no apparent trends were observed between SW and NE elevations or between individual coatings, the results suggest different performances between the groups of water-borne and oil-borne coatings. At least one occurrence of checking was observed for all investigated water-borne coatings (DEFY, Seal Once, Timber Pro, and Sta Brite R). In total, 16 samples coated with water-borne coatings developed checks while only two samples coated with oil-borne coatings (Pine Tar and Chevron) developed checks. Among the water-borne coatings, samples coated with Sta Brite R were most prone to checking (6 samples), followed by Timber Pro (5

samples), DEFY (4 samples), and Seal Once (1 sample). In addition, only Sta Brite R had checking on at least one sample at all three testing sites. No checking was observed on control samples. The possible effect of surface roughness and slope of grain on the incidence of checking was also considered, but there was no correlation and the results are not shown here. The results suggest a higher tendency of shingles to develop checks when they are coated with water-borne coatings, rather than with oil-borne coatings or when uncoated.

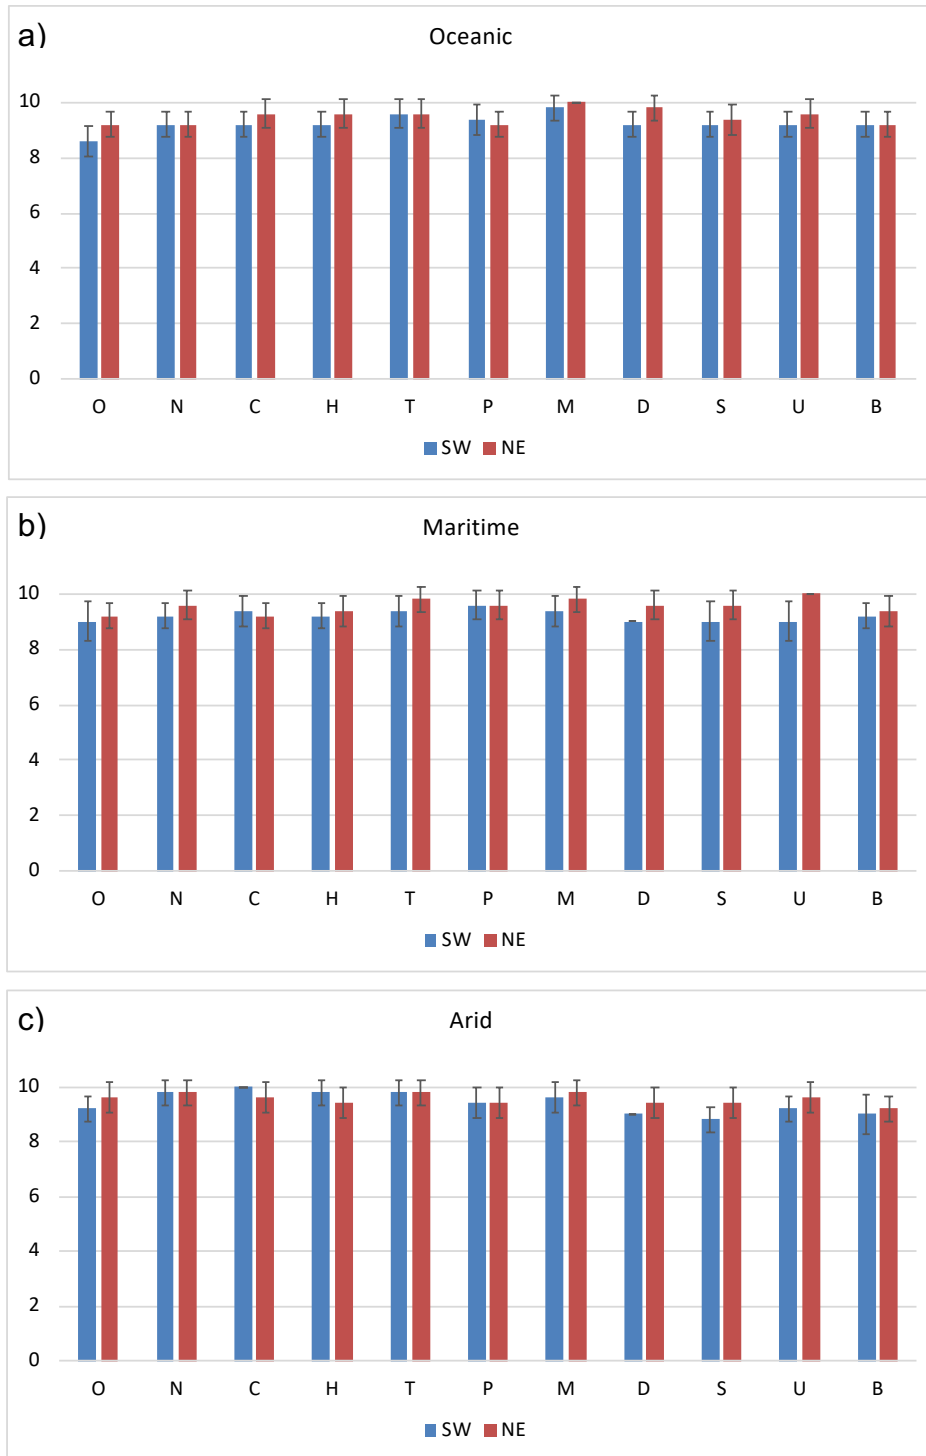
Figure 18. Mean ratings and standard deviation for cupping of shingles following 12-month outdoor exposure for a) Oceanic, b) Maritime, and c) Arid site, for southwest (SW) and northeast (NE) exposure for uncoated control (O), Pine Tar (N), Chevron (C), Heritage (H), TWP 1500 (T), Penofin (P), Messmer's (M), DEFY (D), Seal Once (S), Timber Pro (U), and Sta Brite R (B).

At the Oceanic and Maritime sites, all coated groups performed equally or better than the uncoated control groups and on average exhibited less cupping when compared to control groups (Figure 18). Cupping was also more prominent on SW exposures at both sites, based on an independent-samples t-test conducted to compare cupping at SW and NE elevation (Table 4). At 95% significance level, the difference at the Arid site was not significant, indicating no difference between the amount of cupping at two elevations. Difference in cupping for water-borne coating groups between SW and NE exposures was more pronounced than for oil-borne coatings and contributed most of the observed difference between the two exposures.

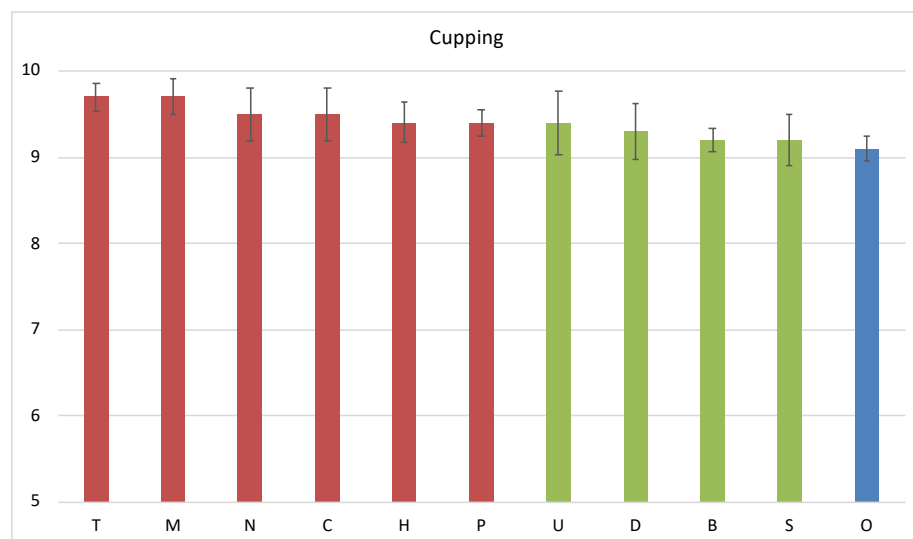
Figure 19. Mean cupping ratings and SD for samples from all test groups (three sites and two elevations). TWP 1500 (T), Messmer's (M), Pine Tar (N), Chevron (C), Heritage (H), Penofin (P), Timber Pro (U), DEFY (D), Sta Brite R (B), Seal Once (S), and Control (O).

No consistent effects of testing site and elevation were observed among individual coatings, although the analysis of the mean ratings for all samples with cupping from all three sites suggests that in general, oil-borne coatings had less cupping than water-borne coatings. TWP 1500 and Messmer's consistently had the least cupping regardless of the exposure conditions (Figure 19).

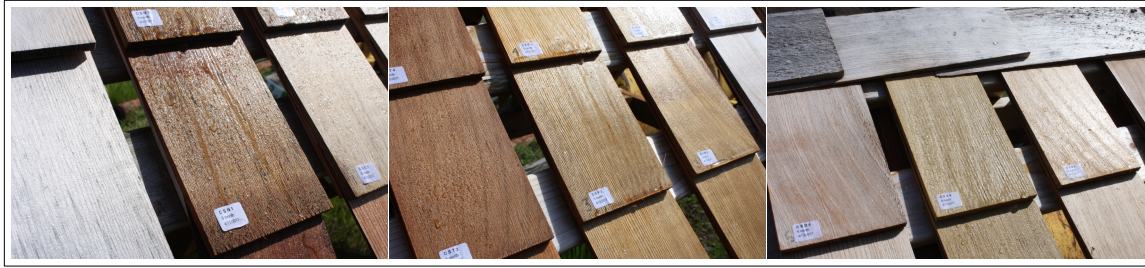
Figure 20. Examples of water beading on shingles during the field testing.

Results for water repellency of test groups based on field evaluation (Figure 20) are presented in Figure 21. There was very little variability in water repellent properties within each test group over the course of data collection. Uncoated control and Sta Brite R coated groups had no water beading on the shingle surface and were assigned the lowest rating of 6 at the time of installation with no subsequent change during the 12-month outdoor exposure.

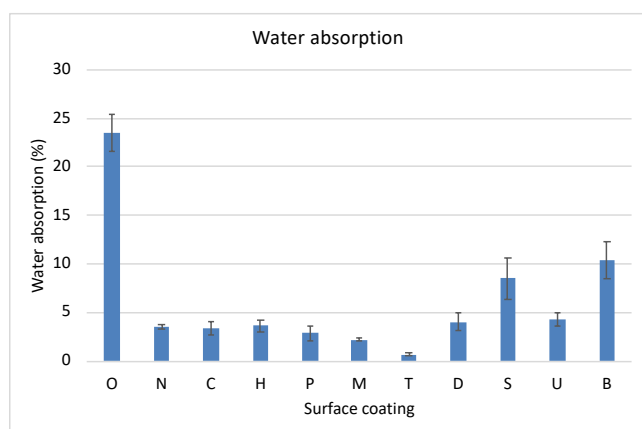
Figure 22. Average water absorption (%) and standard deviation (%) for coated shingles and controls following the laboratory testing. Uncoated control (O), Pine Tar (N), Chevron (C), Heritage (H), TWP 1500 (T), Penofin (P), Messmer's (M), DEFY (D), Seal Once (S), Timber Pro (U), and Sta Brite R (B).

Results for laboratory tests of water absorption and water repellent effectiveness of investigated coatings in shown in Figure 22, Figure 23, and Table 3. For coated groups, average water absorption over 30 minutes of water immersion ranged from 0.7% for TWP 1500 to 10.4% for Sta Brite R, compared to 23.5% for the control group. All coatings significantly reduced water absorption of WRC shingles compared to uncoated controls. Water repellent efficiency, which represents the ability of coating to prevent water absorption relative to uncoated controls, ranged from 55.8% for Sta Brite R to 97.1% for TWP 1500.

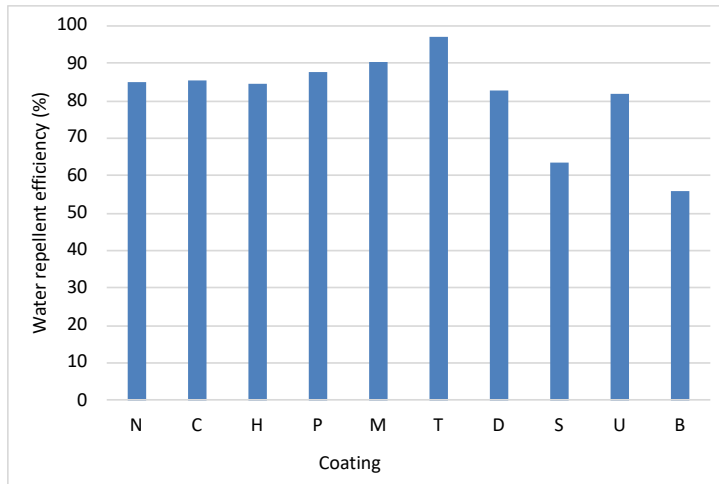
Figure 23. Water repellent efficiency relative to uncoated control samples for laboratory tested water absorption. Uncoated control (O), Pine Tar (N), Chevron (C), Heritage (H), TWP 1500 (T), Penofin (P), Messmer's (M), DEFY (D), Seal Once (S), Timber Pro (U), and Sta Brite R (B).

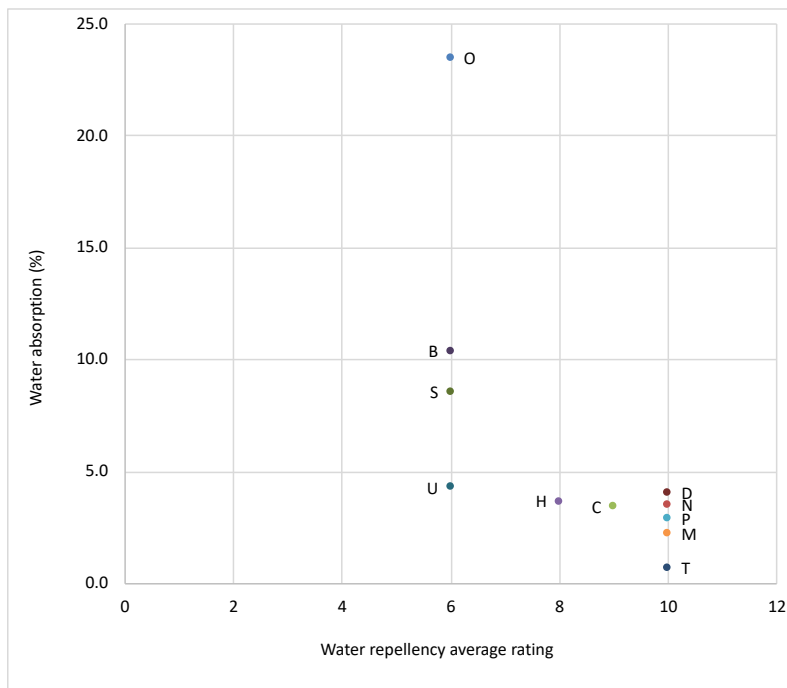
Figure 24. Comparison of water absorption (%) determined by laboratory testing and ranking of water repellency determined in field before the weathering exposure. Uncoated control (O), Pine Tar (N), Chevron (C), Heritage (H), TWP 1500 (T), Penofin (P), Messmer's (M), DEFY (D), Seal Once (S), Timber Pro (U), and Sta Brite R (B).

Figure 24 shows the comparison of water absorption determined by laboratory testing and ranking of water repellency determined in the field before the weathering exposure. As seen in the graph, overall there was a good correlation between laboratory and field results for all coatings with the exception of Timber Pro, which had low water absorption comparable to DEFY in laboratory testing but was rated at 6 as having no apparent water beading during field testing of water repellency.

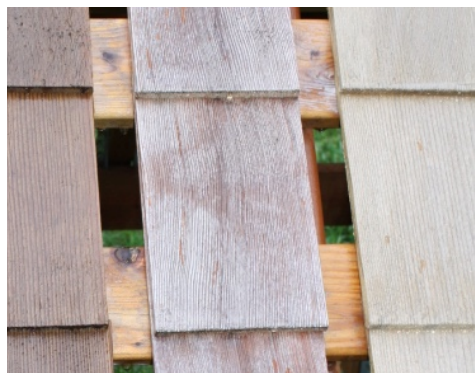
Figure 25. Whitish appearance of wet DEFY coated shingles

In terms of the aesthetic appearance, the most desirable coatings are those that resemble either the original or the weathered color of western redcedar. Heritage and Chevron coated shingles had the closest color to weathered control group after a 12 months exposure at the Maritime and Oceanic sites. The color of other oil-borne coatings Pine tar, Penofin and Messmer's shifted towards natural western redcedar color over the course of the 1st testing phase, and attained considerably darker tones when compared to weathered western redcedar at advanced stages of color loss after 12 months. TWP 1500 retained its original color over the whole year of outdoor exposure, closely resembling the color of unweathered western redcedar heartwood. Water-borne coating DEFY also weathered to a similar appearance as the weathered western redcedar when dry, but a milky white film appeared on the surface when the coating was wet (Figure 25).

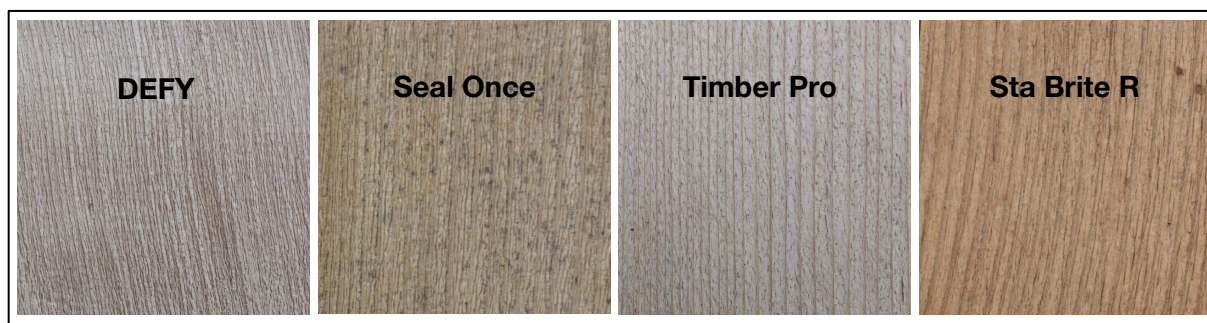
Figure 26. Micro checks on water-borne coatings.

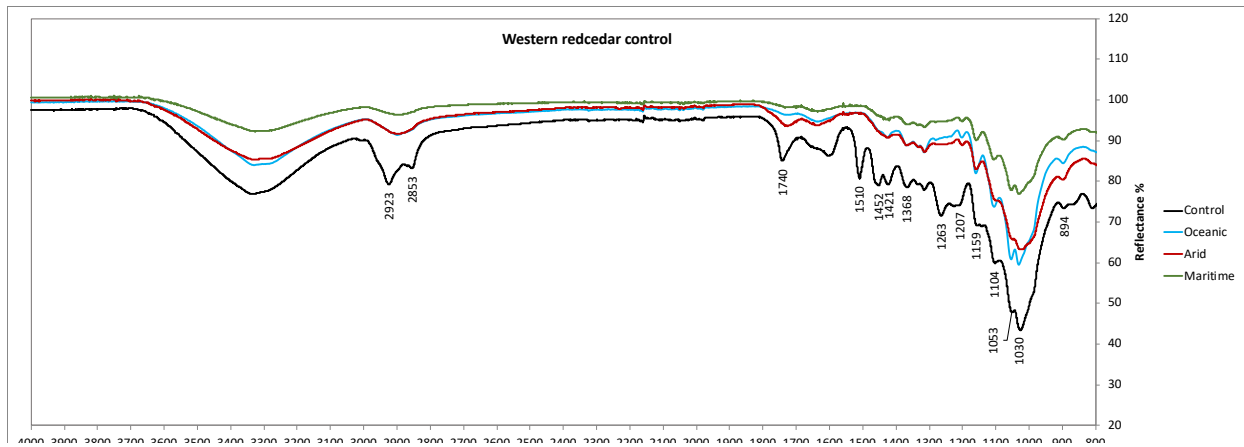
Figure A 1. FTIR spectra of uncoated western redcedar control before weathering and following the weathering at three exposures.

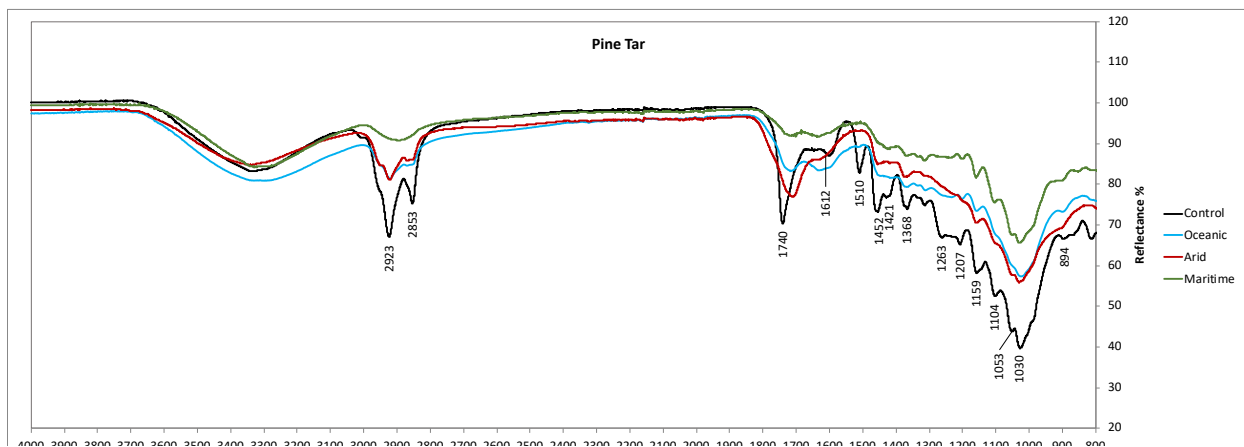
Figure A 2. FTIR spectra of Pine Tar coated wood before weathering (Control) and following the weathering at three exposures.

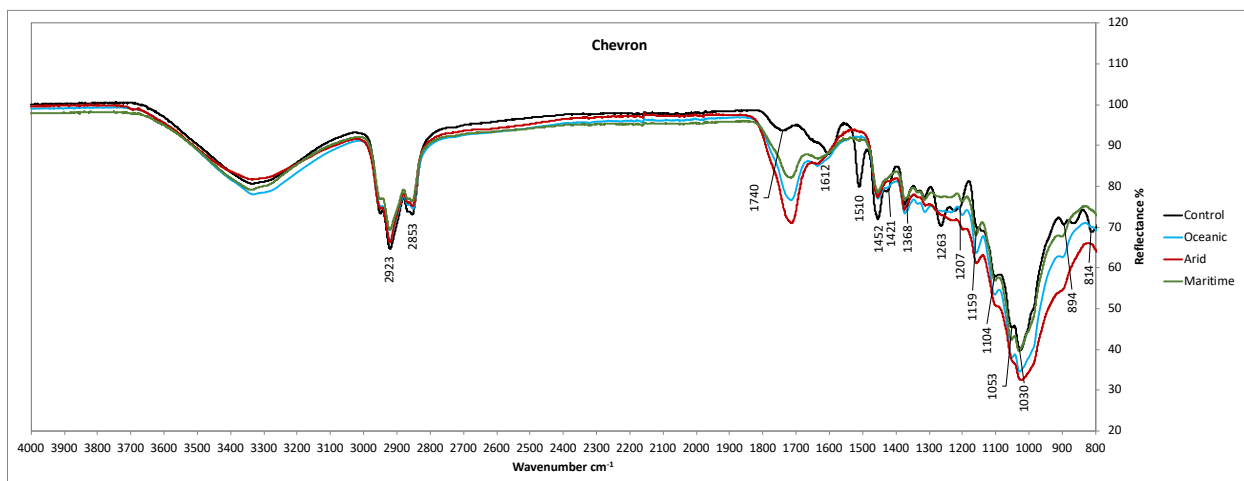
Figure A 3. FTIR spectra of Chevron coated wood before weathering (Control) and following the weathering at three exposures.

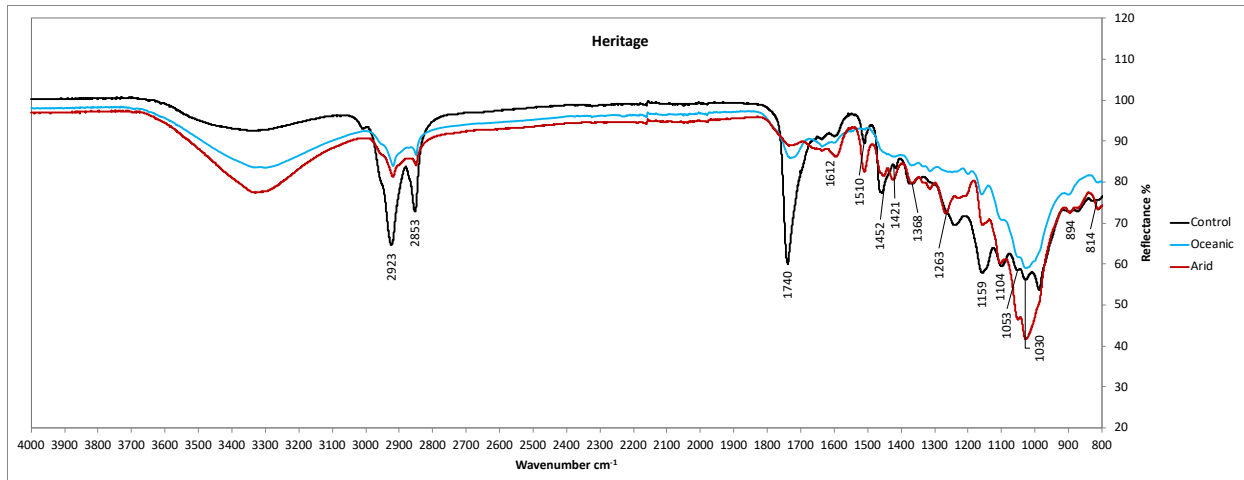
Figure A 4. FTIR spectra of Heritage coated wood before weathering (Control) and following the weathering at three exposures.

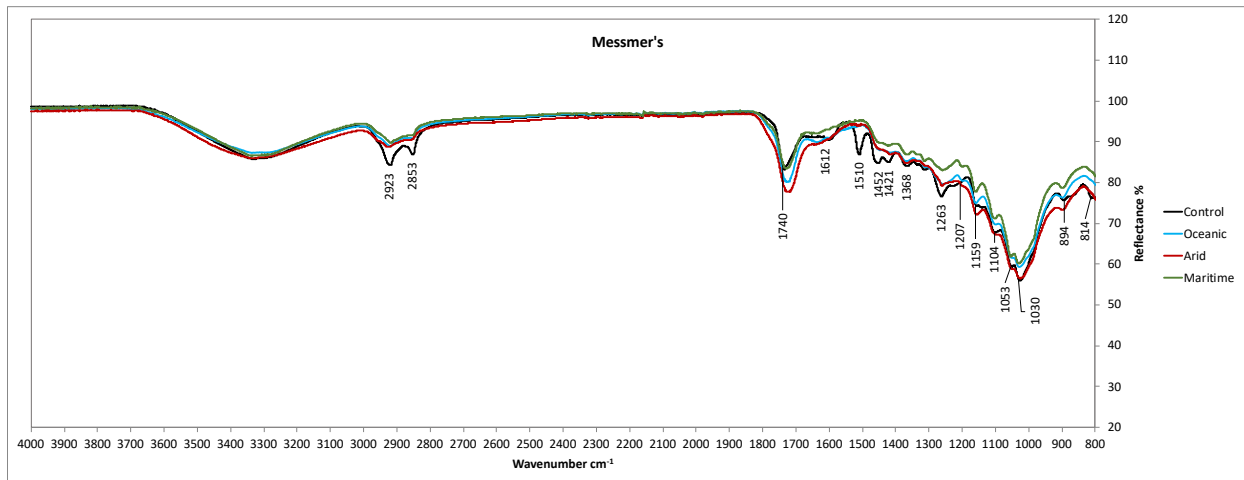
Figure A 5. FTIR spectra of Messmer's coated wood before weathering (Control) and following the weathering at three exposures.

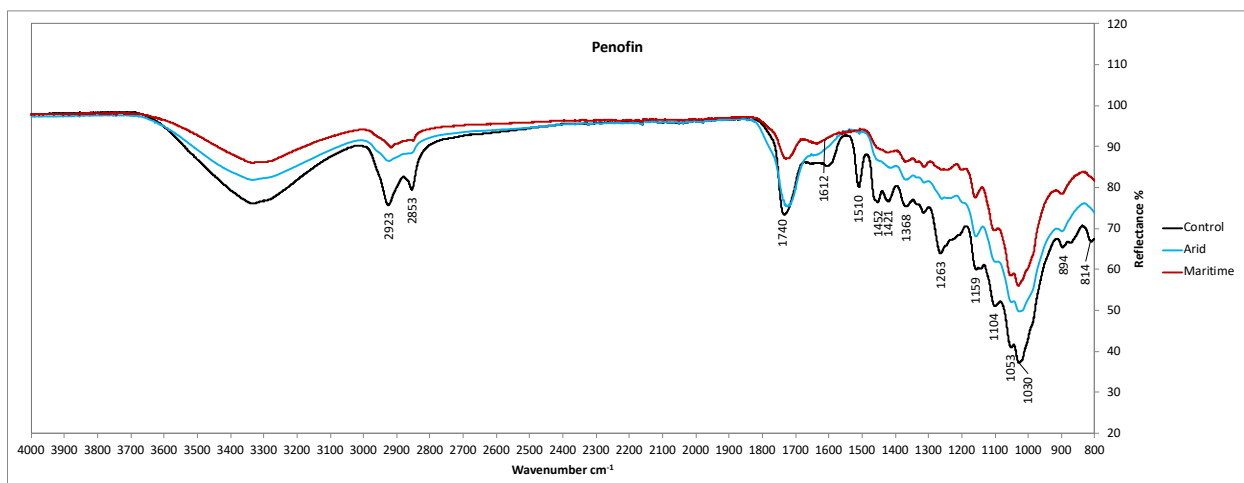
Figure A 6. FTIR spectra of Penofin coated wood before weathering (Control) and following the weathering at Arid and Maritime exposures.

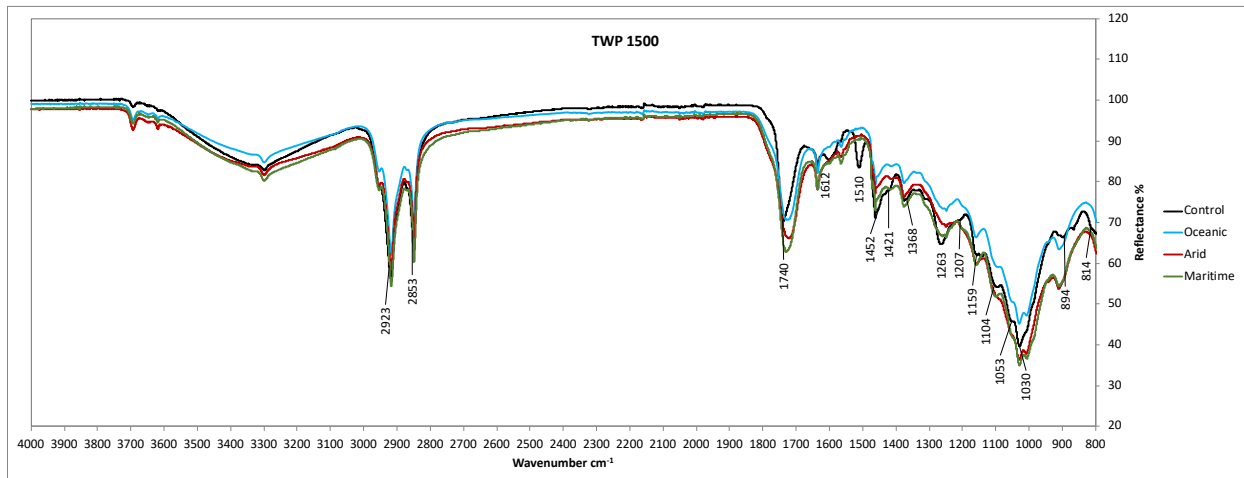
Figure A 7. FTIR spectra of TWP 1500 coated wood before weathering (Control) and following the weathering at three exposures.

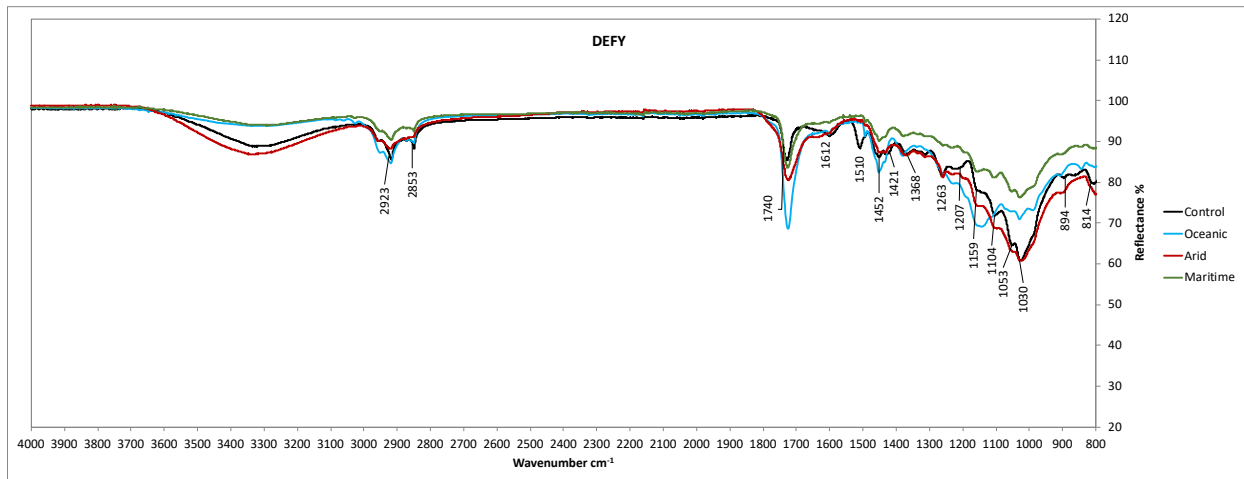
Figure A 8. FTIR spectra of DEFY coated wood before weathering (Control) and following the weathering at three exposures.

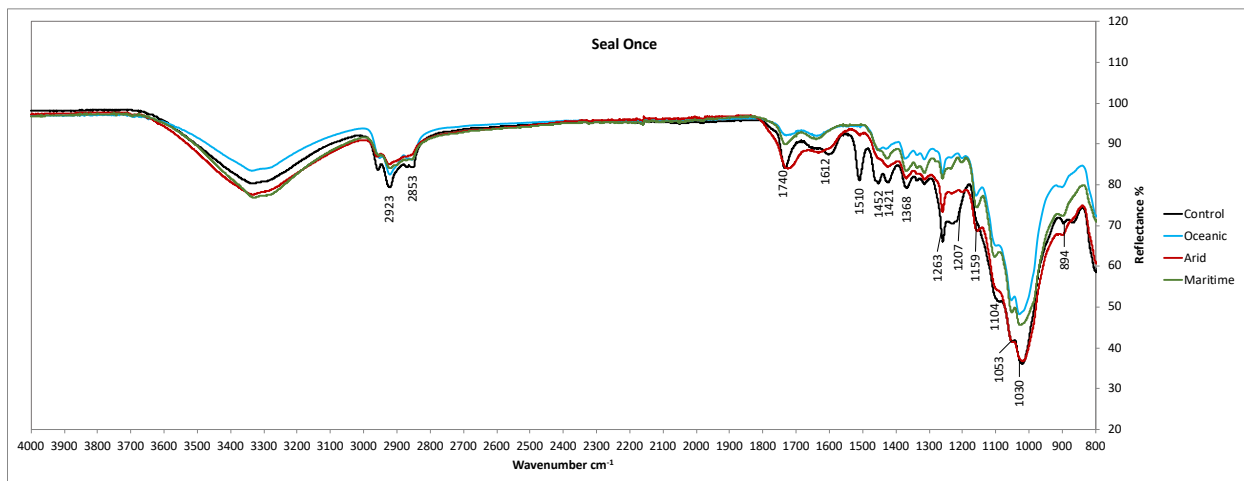
Figure A 9. FTIR spectra of Seal Once coated wood before weathering (Control) and following the weathering at three exposures.

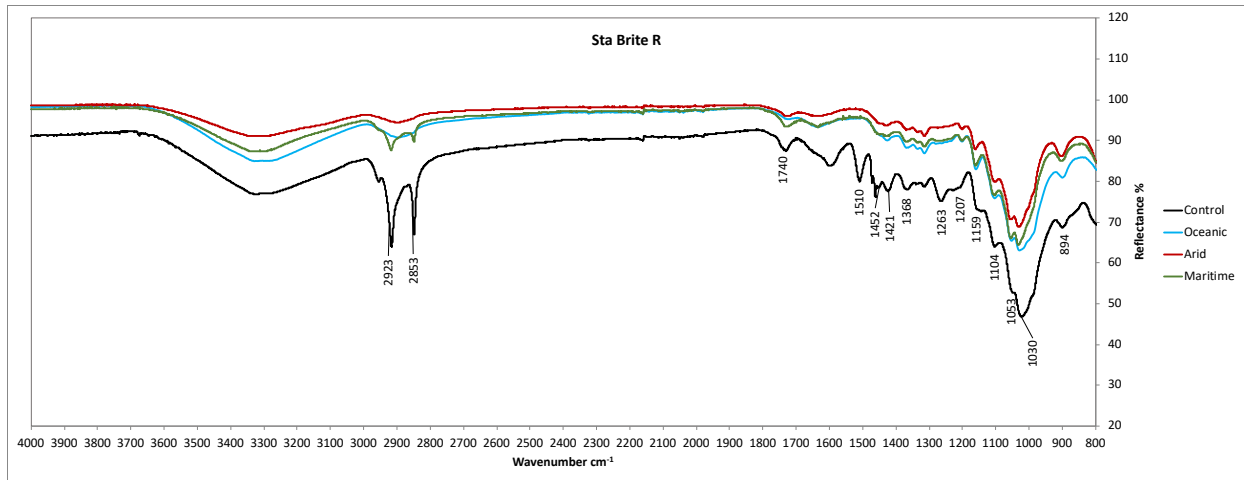
Figure A 10. FTIR spectra of Sta Brite R coated wood before weathering (Control) and following the weathering at three exposures.
